Manhole Inspection Summary

Manhole # S11MM1014MH

Location Address: **4750 PARK HEIGHTS AVE** Cross Street: **WOODLAND AVE**

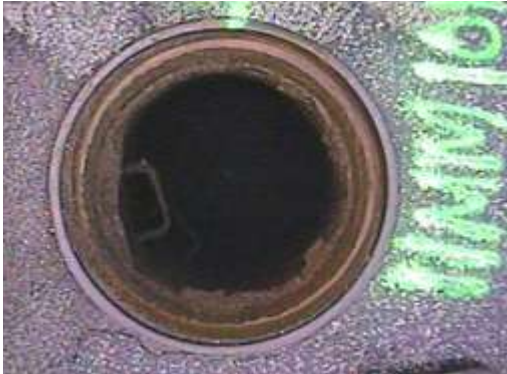
Defect 1

Frame Offset: **1** (in.) Condition: ☒ Sound ☐ Cracked ☐ Leaks

FRAME OFFSET

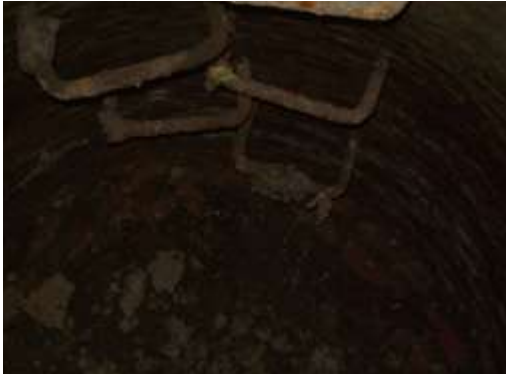
Defect 2

Steps Count: **7** Missing: **0** ☒ **Corroded**

Surcharge ☒ **Evidence Of Surcharge** Depth: **2** (ft.) ☐ Active Surcharge Present

CORRODED STEPS AND EVIDENCE OF ASUR

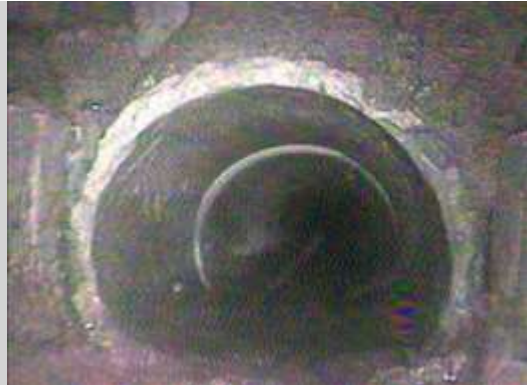
12 O'Clock Outflow

12 in. Circular Gravity Sewer
Pipe Out @ 12 O'Clock

Pipe Height: (in.) Direct
Pipe Material: **Clay** ☐ Pipe Lined
Invert Depth: **13.81** (ft.) Flow Characteristics: **Fast**
Deposits: ☒ None ☐ Mud ☐ Sludge ☐ Debris ☐ Grease
Silt Depth: (in.) Deposits Extent:
Infiltration: **None** Pipe Seal Cond: **Sound**

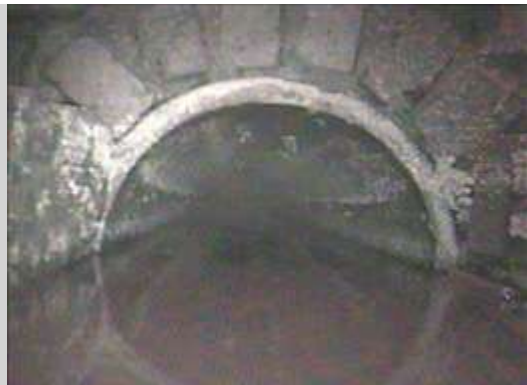
3 O'Clock Inflow

12 in. Circular Gravity Sewer
Pipe In @ 3 O'Clock

Pipe Height: (in.) Direct
Pipe Material: **Clay** ☐ Pipe Lined
Invert Depth: **13.80** (ft.) Flow Characteristics: **Fast**
Deposits: ☒ None ☐ Mud ☐ Sludge ☐ Debris ☐ Grease
Silt Depth: (in.) Deposits Extent:
Infiltration: **None** Pipe Seal Cond: **Sound**
